F-14 WIRING SYSTEM AWARENESS

PREVENTING WIRING SYSTEM FAILURE

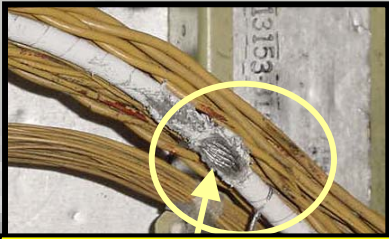
First bay aft of nose,
right side. Bare power
wire.

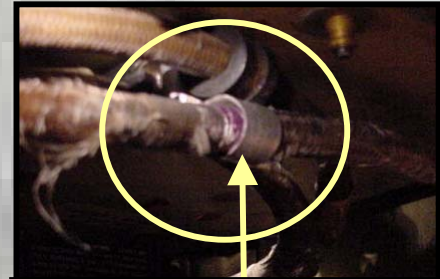
Clamp missing rubber.

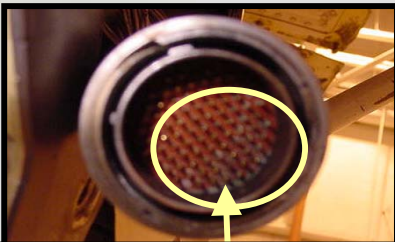
Second bay aft of nose,
right side. Corroded
connector and pins.

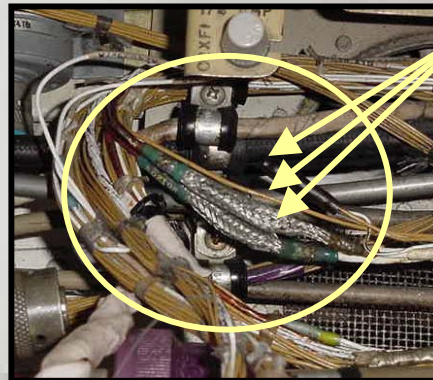
Metal
over-braid
chafing
misrouted
wiring.

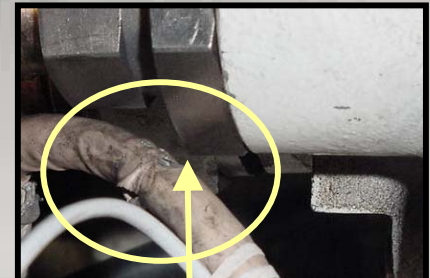
Coax has excess length
causing a chafe condition
on hydraulic line "B" nut.
Coax has exposed shield.
